Amulsar Gold Project: Overview of Concerns with the Amulsar Gold Project, Potential Consequences, and Recommendations

**Report prepared by:
Blue Minerals Consultancy
Buka Environmental
Clear Coast Consulting**

January 2018

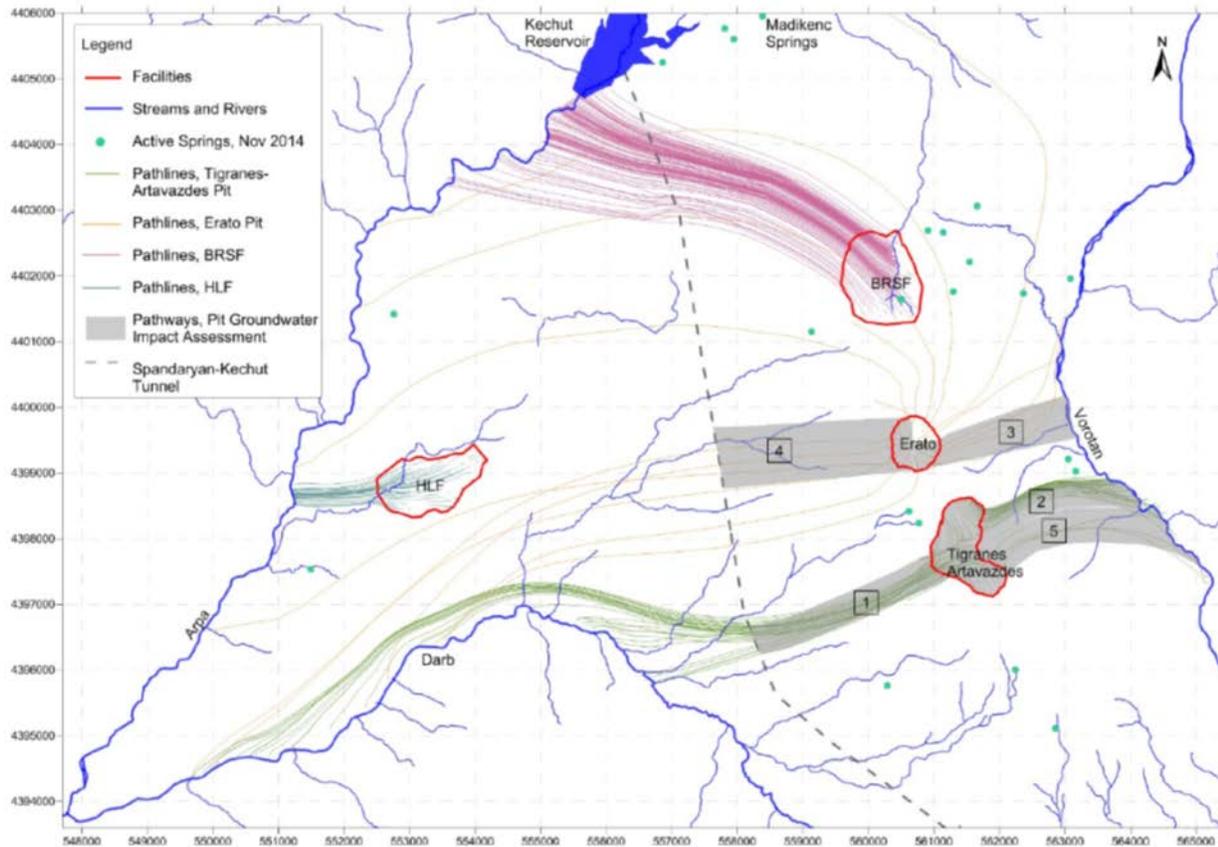
Figure 1. Groundwater flow paths during post-closure. Flow paths for water and contaminants from the barren rock storage facility (BRSF; waste rock dump), the heap leach facility (HLF; where gold is extracted from ore using a cyanide solution), and the open pits (Erato, Tigranes, Artavazdes; where ore and wastes are extracted) to the Arpa, Darb, and Vorotan rivers; springs; the Spandaryan-Kechut Tunnel; and the Kechut Reservoir are shown as colored lines (different colors for different mine sources). Flow paths from the Erato Pit (in yellow), which will not be backfilled, reach nearly all receptors, including the Arpa River upstream of the Kechut Reservoir. Gray numbered flow paths represent flow paths from the pits evaluated in Golder Associates (2014a). Note that the groundwater model used to identify the flow paths did not consider the abundant faults in the area that could bring contaminants more quickly, and with less dilution, to unanticipated receptor locations (Golder Associates, 2014b).

Source: Lydian International, 2016. Chapter 6.9, Figure 6.9.3.

Figure 1. Groundwater flow paths during post-closure	2
--	---

- Lydian International, 2016. Amulsar Gold Mine Project. Environmental and Social Impact Assessment (ESIA). Chapter 6.9 Groundwater Resources. Figure 6.9.3. Available: <http://www.lydianarmenia.am/resources/geoteam/pdf/a70da61db241d7c9c609ffb0ea842f91.pdf>
